Flight Results of the COMPASS-1 Mission

Artur Scholz¹, Felix König², Steve Fröhlich², Johannes Piepenbrock²

²Department of Aerospace Engineering, FH Aachen University of Applied Sciences, Germany

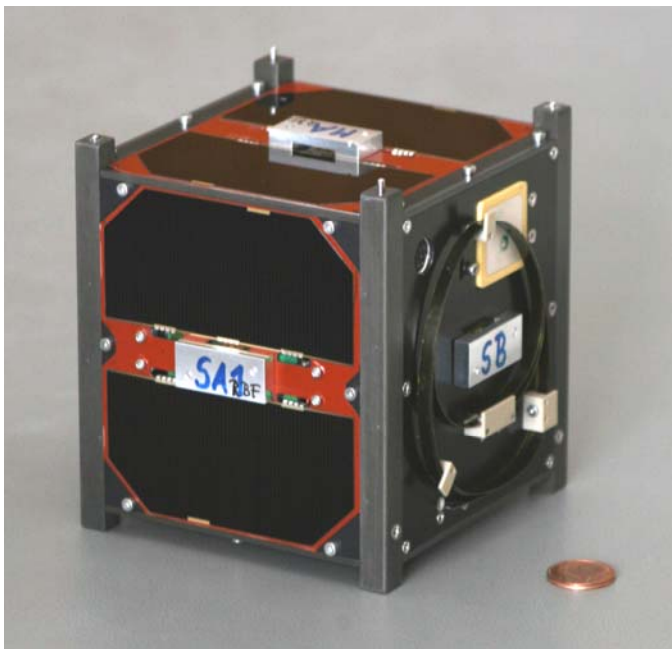
Figure 1: The COMPASS-1 Flight Model

The satellite structure is made by 5-axes machining of Al-6061 to ensure the required tolerances and offer a rigid housing for all other subsystems. The hard-anodized corner bars are the guiding guidance for the ejection from the storage container. These bars also include the shutdown switch mechanism. After ejection from the container, the contact closes the main power circuit causing the satellite to boot its system for operation. Another important mechanism is the deployment of the antennas following the separation from the launch container. This is achieved by melting of a nylon wire that holds the ends of the stowed

antennas together (see Figure 1). Once the wire is melt, the antennas release into their flight configuration.

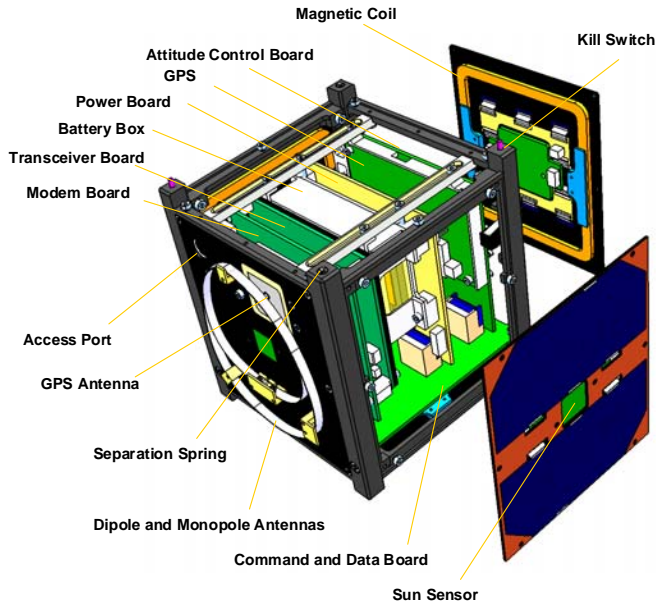
Figure 2: Configuration of the satellite

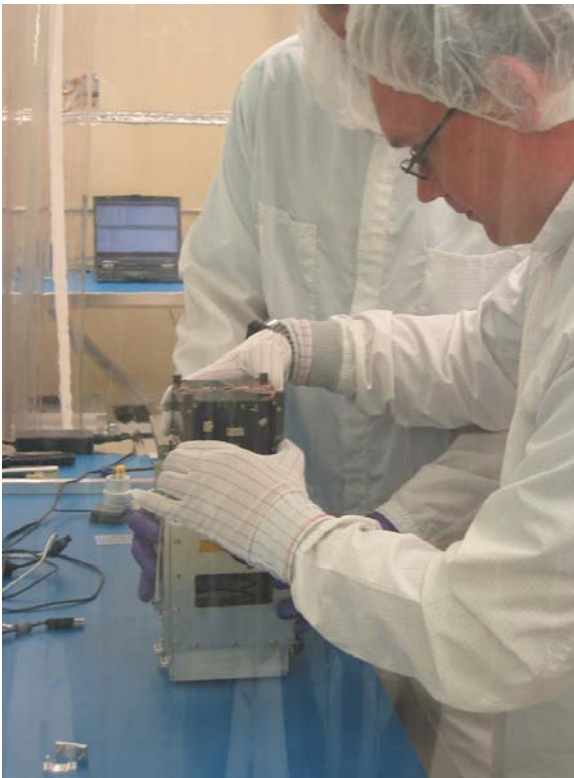
Figure 3: Insertion of COMPASS-1 into its X-POD

At the integration campaign at SLF, COMPASS-1 was inserted without problem in its X-POD container and this configuration was mechanically stressed with extensive vibration tests at MacDonald, Dettwiler and Associates Ltd. (MDA), Brampton. The analyses of those tests and subsequent functional test and visual inspections of the satellite and the X-POD had shown that no damages had arisen and that both together can withstand the harsh conditions during the launch. Finally, COMPASS-1 was set into flight configuration - ready for shipment to the launch site.

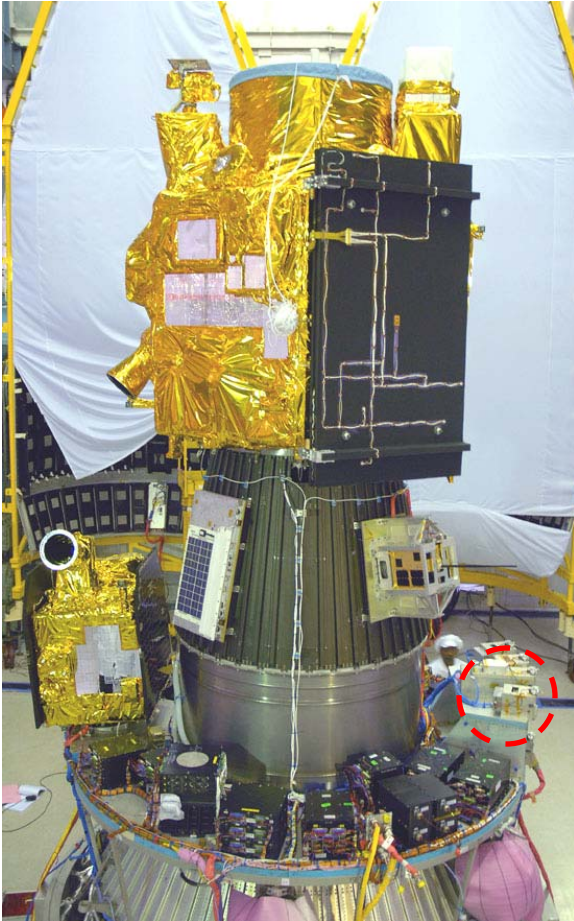
Figure 5: PSLV-C9 upper stage with satellites

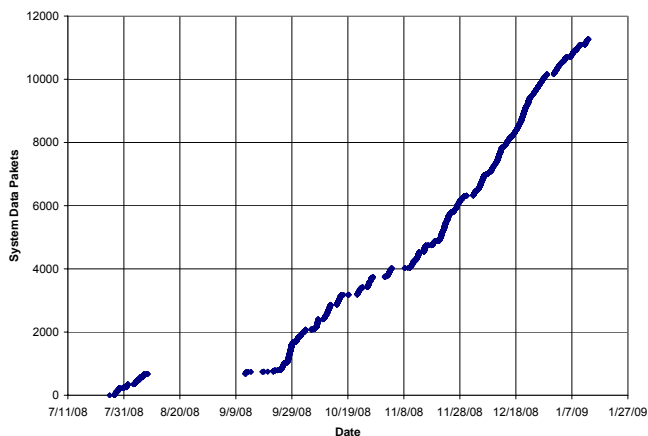
Telemetry of the satellite's health is recorded by the CDHS at intervals of approximately 7 minutes. The allocated 80 Kbyte memory block for health data allows for a continuous recording of almost forty hours until a download of the data becomes necessary. The large interval between the recordings allows to compactly store data over a long duration and results in qualitative diagrams of the satellites' health status over the course of the mission operation. The accumulation of downloaded data is illustrated in Figure 7. During the time from August to early September 2008 no system health data could be downloaded from the satellite for the reasons explained earlier. From then onwards the downloading of data became more routinely and continuous, which resulted in an almost linear accumulation of data. At around November, the downlink was switched to a higher transmission rate, observable as a buckling in the curve. The ADCS also continuously records information about the satellite. The interval of data recording is 10 or 2.5 seconds during sun time or detumbling, respectively. Naturally, the ADCS data is focused on attitude determination and control parameters, such as attitude sensor readings. However, also the temperatures of the ADCS board and the sun sensors are recorded, which are useful for a more quantitative evaluation of the satellites' thermal behavior.

Figure 7: Accumulated system data

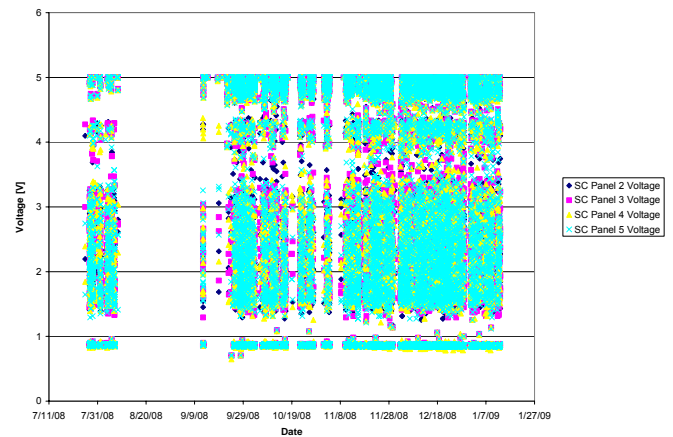
Measurements of the output voltages of the solar cell strings on side 2 to 5 are depicted in Figure 8. The voltage measurement sensor for the SC string on panel 6 was erroneous and did not deliver measurements. (See Figure 12 for the numeration of the side panels). For each string the output voltage measurements are fairly evenly distributed within the range from about 0.8 Volt (the diode forward voltage drop of the string) to about 5 Volt (the open circuit voltage of the string). This is so because the solar cells are body-mounted and are illuminated under minutely changing incident angles.

Figure 8: Solar cell voltages

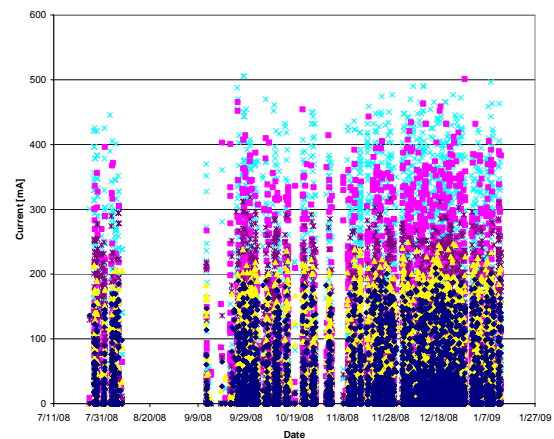
Figure 9: Solar cell currents

Figure 9 plots the current measurements for all solar cell strings over the mission time. What strikes the eye first is the high range of the SC string output on panel 3 and 5 (both reaching the maximum specified output current). The SC strings on panel 6 is in the mid range (about half the maximum current), whereas those on panel 4 and 2 have the lowest current output range (less than 50% of maximum). This is assumed to be caused by improper calibration.

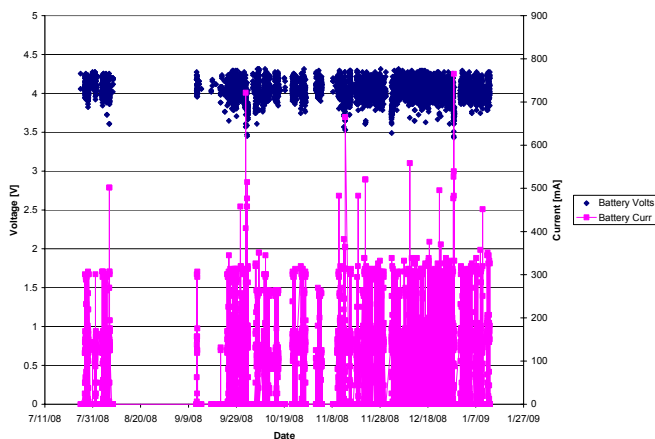
Shown next is the status of the battery over time. The battery voltage does not fall below 3.4 Volt in the diagram, since this is the threshold for the emergency mode during which no measurements are recorded. Hence, during nominal operation the battery voltage is in the range of 3.4 to 4.2 Volts. The output currents from the battery pack go up to approximately 330 mA, with a few peaks going up to more than 1 Ampere.

Figure 10: Battery voltage and output currents

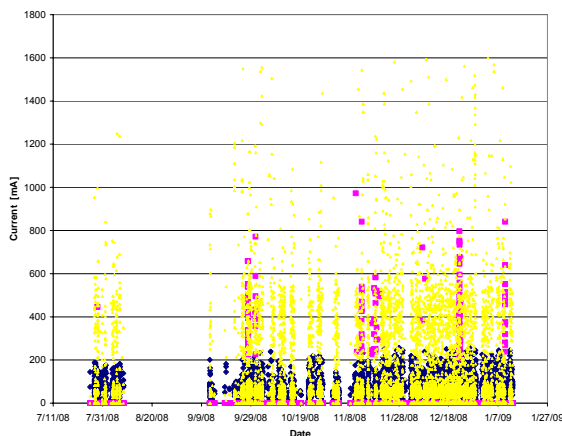
Figure 11: Supply currents

The supply currents on the other hand provide a better insight about where the electrical power is consumed. In Figure 11 the currents on the regulated 3.3 V and 5 V line, as well as on the unregulated supply is shown. The regulated supplies are used for the CDHS and ADCS, whereas the unregulated line is used for the supply of the power regulators for heater, EPS and COM. The consumption on the 3.3V supply remains evenly within a maximum of about 260mA, with an average consumption 76mA. The loads on the 5 Volt supply have an average of just 5.5mA, with peaks up to almost 1A. This is due to the fact this line is used for the attitude control actuators and the GPS system, both drawing high currents for short durations. Finally, the current on the unregulated supply (i.e. the loads from EPS, TCS and COM) are on an average of 160mA, with peaks up to 1.6A. Apparently these high currents are caused by the operation of the heaters, the FM transmission and beacon.

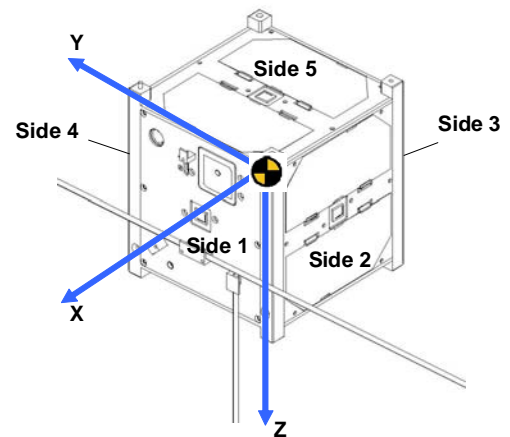
Figure 12: Side panel numeration and body axes definition

The objective of the ADCS is to align the satellite's body axes (see Figure 12) with the orbit reference frame. Therefore the system must measure its current attitude and produce appropriate magnetic control moments if a deviation between actual orientation and reference orientation is detected. The following discussions on the attitude determination performance is using satellite attitude information data recorded between 3rd of January 2009, UTC 20:48 till 4th of January, UTC 01:07. The data from other dates lead to similar results.

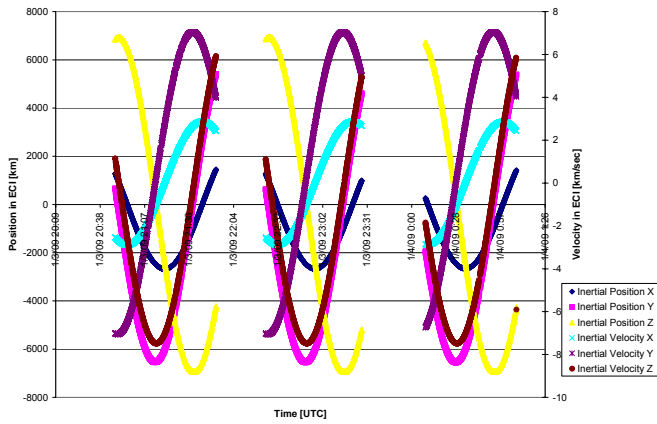
For the attitude determination, knowledge about the position of the satellite in its orbit is needed. This knowledge is generated from two pieces of information that are uploaded to the satellite and updated once in a while: the general orbit information (Kepler elements), and the actual time (in UTC). Figure 13 plots the on-board generated inertial position of the satellite during sun times for a selected time interval of about three orbits. The difference between the estimated and the real position coordinates are plotted in Figure 14, which shows that the errors are less than 100 km in magnitude for the second and third orbit in that plot. (Note that only during sunlit times data is available and plotted in the graph). This is an acceptable result given the limited accuracy of the on-board time-keeping and processing capabilities. However, for the first orbit in that plot the errors are too high and will result in a degraded accuracy of the attitude determination during that specific orbit.

Figure 13: Output of the satellite's orbit propagator

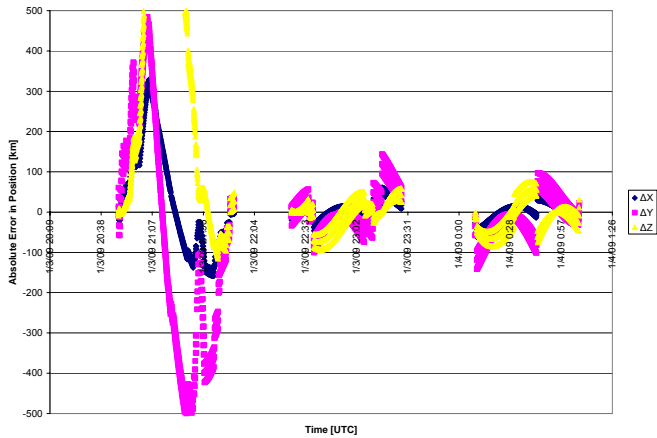
Figure 14: Absolute errors of position determination

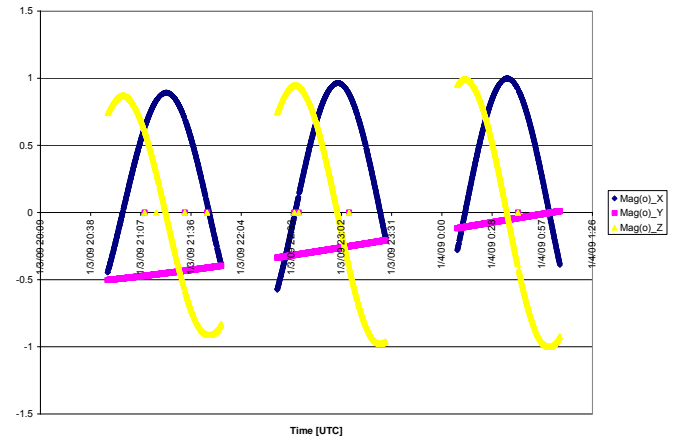
The implementation of the earth magnetic field model on COMPASS-1 comprises of the geomagnetic main field spherical harmonics expansion IGRF-10 and its secular variation to full degree and order (13 and 8, respectively) evaluated in 0.5° increments in longitude and latitude, stored in an on-board Flash memory. Figure 15 shows the on-board earth magnetic field unit vector, as generated from the stored look-up table. As a comparison figure 16 plots the same vector as generated by the STK software, by direct evaluation of a full order IGRF model. The striking difference is the apparent flip of the X axis, and the offset in the Y axis. The cause for this is unknown to the authors and might be explained as an erroneous rotation of the magnetic field model for 180° around the Z axis. Unfortunately this dooms the magnetometer useless for the attitude determination.

Figure 15: On-board model of the earth magnetic field unit vector

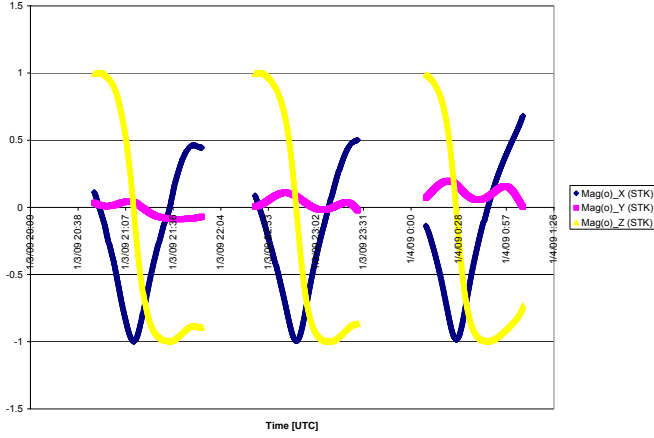
Figure 16: Full IGRF model of the earth magnetic field unit vector as generated with STK

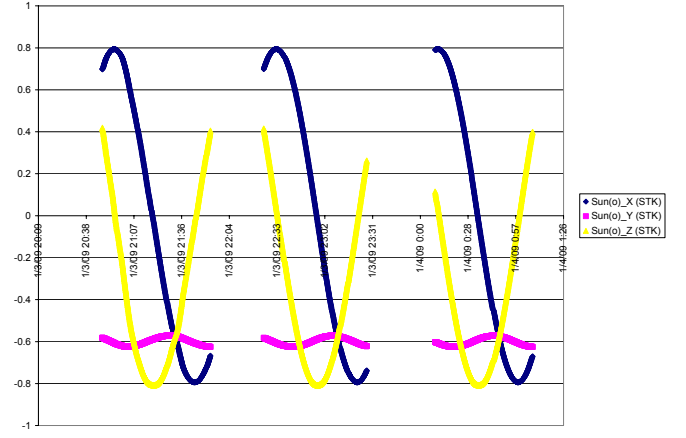
Figure 18: Sun-line unit vector as generated with STK

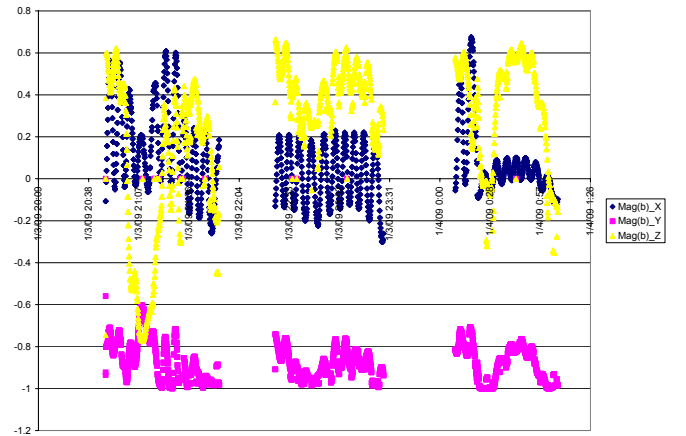
The reference models provide vectors in the orbit frame, whereas the measurements from the sun sensors and the magnetometer are taken in the body frame. The QUEST algorithm aims to find the quaternion that rotates the measured vectors with the reference vectors, hence yielding the attitude of the satellite. The measurements of the magnetic field provided by the magnetometer are shown in Figure 19. Note that the measurements are already unitized and are corrected from predetermined offsets. The measurements look very reasonable and indicate a slow rotation (about 1 rotation per orbit) about the Z axis and nutations about the X and Y axes.

Figure 19: Measured earth magnetic field unit vector

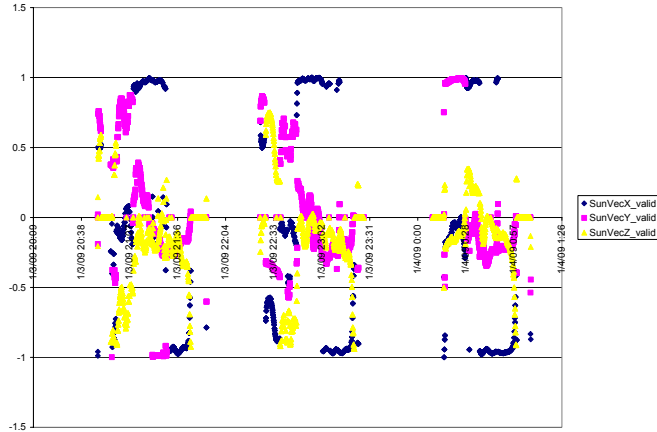
The sun vector as obtained from the five sun sensors (the sun sensor with highest output wins the voting) is shown in Figure 20. The data is taken from the raw

measurements. Apparently the output is heavily corrupted and even though some periods show continuous behavior, an overall trend of rotation is not identifiable. It must also be mentioned that the ADCS status data did never indicate a valid measured sun vector, which as a result renders the attitude determination process per se impossible.

Figure 20: Measured sun unit vector

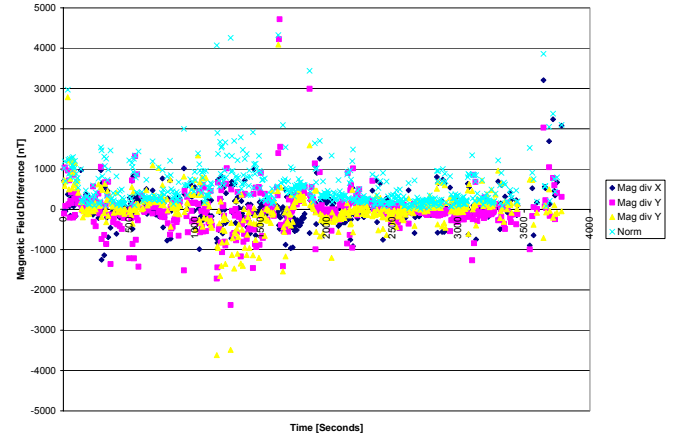
Figure 21: Change of measured magnetic field vector

The graph shows that the change of the magnetic field vector as seen in the body frame is in the order of 1000nT of magnitude for a sampling time of 5 seconds. This indicates that the satellite is not tumbling much at that time, as its rate of change of the magnetic field is not by much greater than the values for an inertial fixed satellite (which is in the order of 60nT per second).

The other, much simpler control algorithm implemented in COMPASS-1, for the detumbling of the satellite. This controller is based solely on the measurements of the magnetometer and sizes a magnetic torque proportional to the difference in subsequent measurements of the magnetic field (i.e. the change of the magnetic field). During the detumbling no time or position information is needed and recorded. Hence, the data as presented in the following cannot be attached to a specific date but merely plots the satellite's motion over a certain period of time for which the detumbling mode was active. Due to the tumultuous time after satellite launch, the data from the first detumbling maneuver could not be downloaded before it was overwritten and hence the data in Figure 21 is presented as a representative sample of the detumbling mode as activated at an arbitrary time during the mission operation.

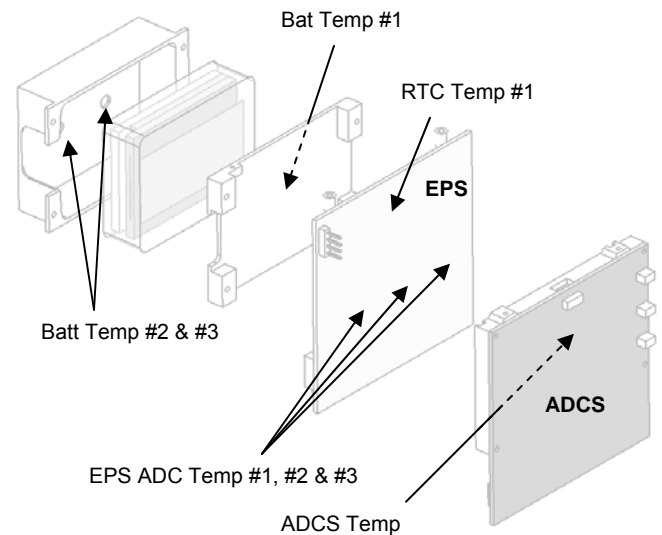
Temperature measurements are collected at an interval of approximately 7 minutes. The location and labeling of the temperature sensors is shown in Figure 22 and Figure 23.

Figure 22: Location of temp sensors at boards and battery box

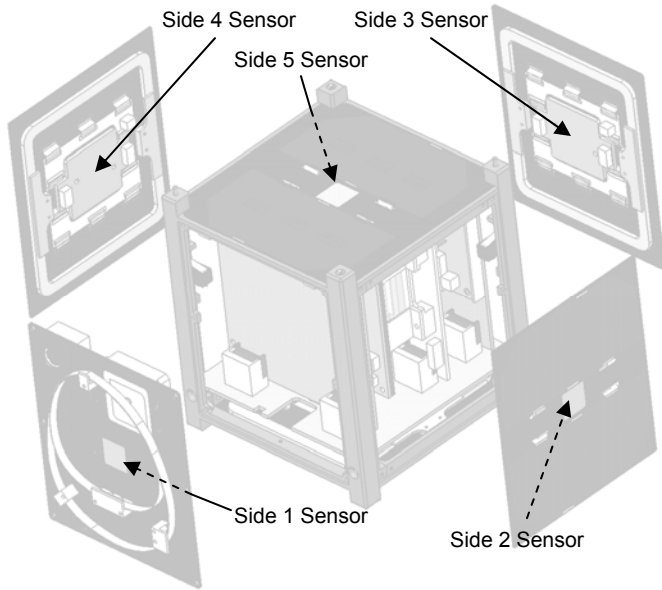
Figure 23: Location of temp sensors at side panels

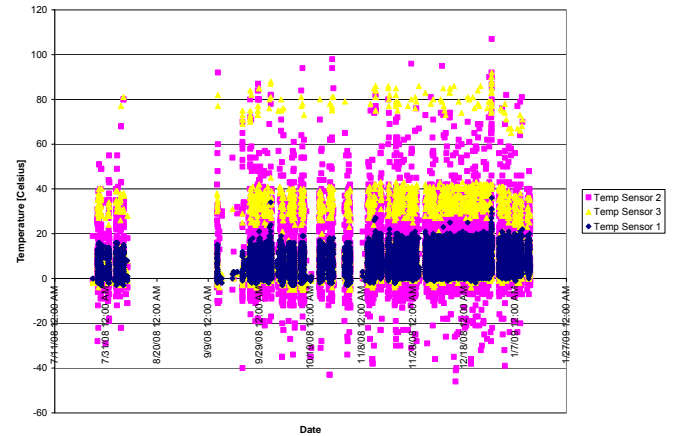
Figure 24 shows the temperatures appearing inside the battery box. While sensor #1 remains in a relatively narrow range from about 0 to +20 °C, the two sensors at the opposite casing of the aluminum box show much stronger fluctuations. This can be explained by the fact that this casing is thermally bonded to the transceiver heat sink (see Figure 2) that heats up during the operation of the transceiver. Yet the temperatures from those two sensors still seem to be quite high. Perhaps electromagnetic interference from the transceiver might have caused noise on the sensors. A particularly odd phenomenon is that the very low temperatures picked up by sensor #2 are not confirmed by sensor #3, which is mounted right next to it.

Figure 24: Temperatures inside the battery box

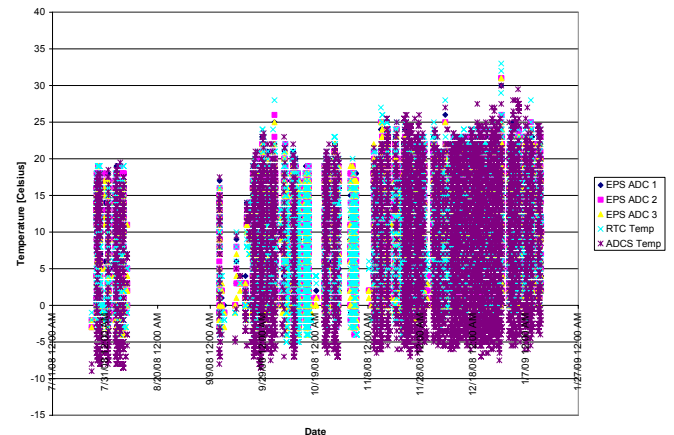
The next figure plots the temperatures of the sensors on the EPS and ADCS boards. All sensors are in close proximity and have almost identical temperature ranges. Interestingly it can be observed that the temperatures in general are rising over the plotted time. The reason for this lies in the increased solar flux at winter solstice. Temperatures range from less than -5 to about +30 °C.

Figure 25: Temperatures at the subsystem boards

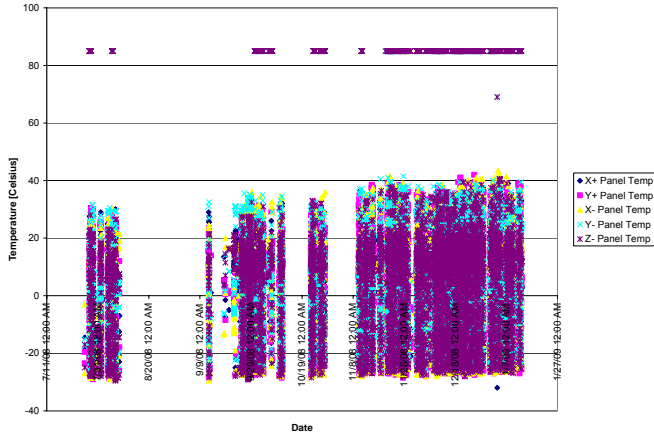
In Figure 26 the temperatures measured on the back side of the sun sensors are plotted. The sensors are not exposed to direct sunlight but face the inside of the satellite. Their range is from about -30 to +40 °C. The same trend of increase in temperature as in the previous figure can be observed.

Figure 26: Temperatures at the inside facing surface of the sun sensor boards

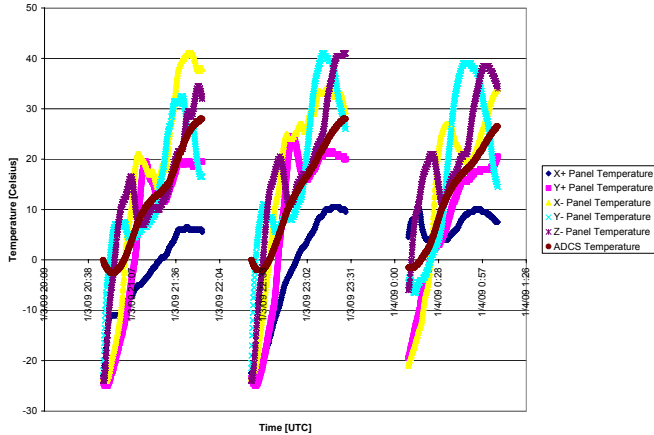
The ADCS system is also recording its temperature measurements of the ADCS board and at the sun sensor boards. The time step between each measurement is 10 seconds and so the plot in Figure 27 for the time interval of about three orbits provides a good insight into the thermal behavior during transitions from eclipse into sun.

Figure 27: Temperatures as measured by the ADCS during a period of approximately three orbits.

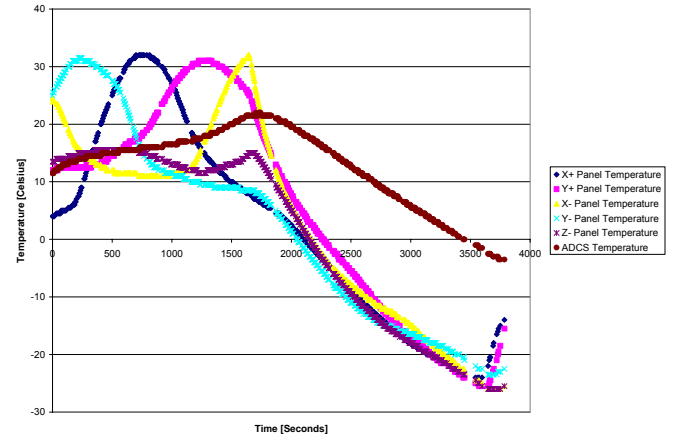
The temperatures in Figure 28 and Figure 29 were recorded during detumbling maneuvers at an interval of 5 seconds. The data is recorded continuously over a period of about 60 minutes. In both plots the transition from sunlight into eclipse is observable as an abrupt falling of the measured temperatures. It is also noticeable that the temperature decrease in eclipse is quite

homogenous for all side panels reaching a minimum of about -26°C , whereas the ADCS board preserves its temperature much better. Finally, at the end of the plot in Figure 28 it can be seen that the satellite is just entering the sun phase again.

Figure 28: Temperatures recorded during detumbling (#1)

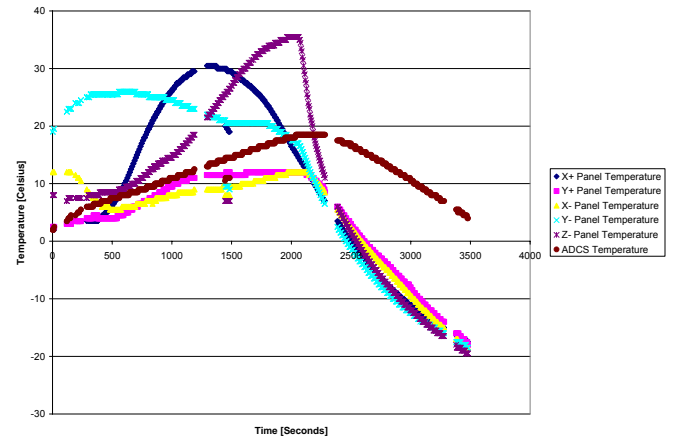
Figure 29: Temperatures recorded during detumbling (#2)
